The 3rd International Geography Symposium - GEOMED2013

Earthquake hazard assessment in Turkey: the Mw = 7.4, Gölcük (August 17, 1999) and the Mw=7.1, Düzce (November 12, 1999) earthquakes

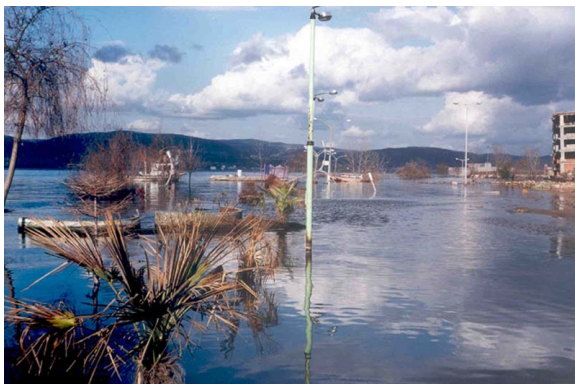
Fig.2. Inundation by seawater due to coastal subsidence near Gölcük

1. South of Izmit Bay: Degirmendere Gölcük and surrounding areas in the south of Izmit Bay: Residential areas along a 100 m wide strip of the Degirmendere coast were completely destroyed by the earthquake. In Kavaklı and Gölcük, landslides occurred on the flat areas between the shore and the road, mostly on filled-in areas (Fig. 2).

Collapsing events and landslides that have occurred between the shorelines and the road in the Kavakli and Gölcük region were seen mostly in filled-in areas (Fig. 2). The deformations involved collapses, sliding and warping, and lead to important geomorphologic changes in the coastal zone. However, some damage is specifically related to strong ground shaking such as the collapse in the central coastal zone of Gölcük and Sapanca Lake.

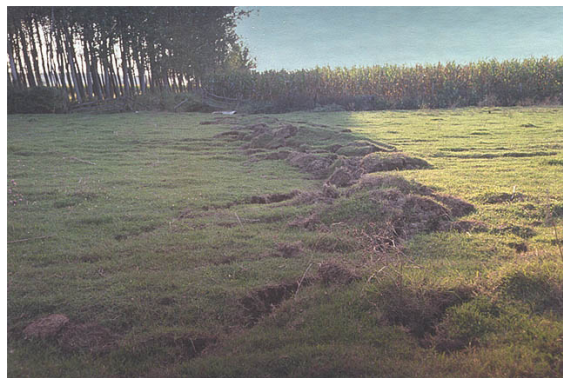
Fig.3. Mole track along the ground rupture near Akyazı .

Surface Ruptures: The Gölcük earthquake caused a surface rupture that is 125 km long (Fig. 3). The surface rupture is observable in many locations between Gölcük and Gölyaka. However, another rupture, which is 43 km long, occurred as a result of the Düzce earthquake to the east of the Gölcük fault. The total length of the two ruptures is approximately 168 km. The maximum right-lateral slips were observed at Gölcük (4 m) and Arifiye (4.5 m).

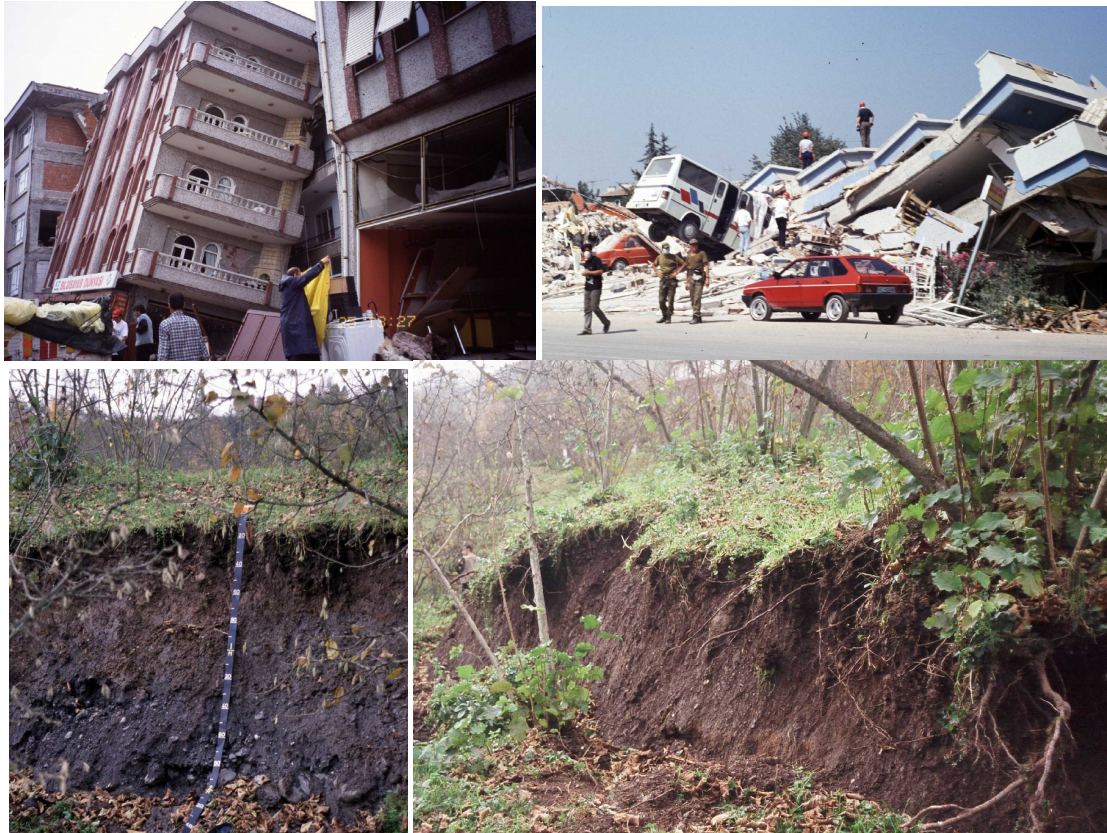
Fig. 5. Adapazari (upper left), Gölcük (upper right), Gölyaka-Düzce (lower left and right).

4. Hacıyakup and the surrounding areas around Efteni Lake (Fig. 5).
