# Post-Earthquake Strengthening of RC Coupling Beams with GFRP Wrapping: Experimental Investigation

**Abstract:** This research aims to address a post-earthquake urgent strengthening measure to enhance the residual seismic capacity of earthquake-damaged reinforced concrete wall structures with coupling beams. The study consists of a series of tests on half-scale prototype coupling beams with various detailing options, including confined with reduced confinement, partially confined, and unconfined bundles, under cyclic loading conditions. The methodology employed involved subjecting the specimens to displacement-controlled reversal tests, and carefully monitoring their response using strain gauges and potentiometers. The main results obtained reveal that GFRP wrapping significantly enhances the seismic performance of earthquake-damaged coupling beams, even in cases where specimens experienced strength loss and main reinforcement rupture. The strengthened beams exhibit commendable ductility, maintaining high levels of deformation capacity, and satisfying the requirements of relevant seismic design codes. The significance of the study lies in providing valuable insights into the beha

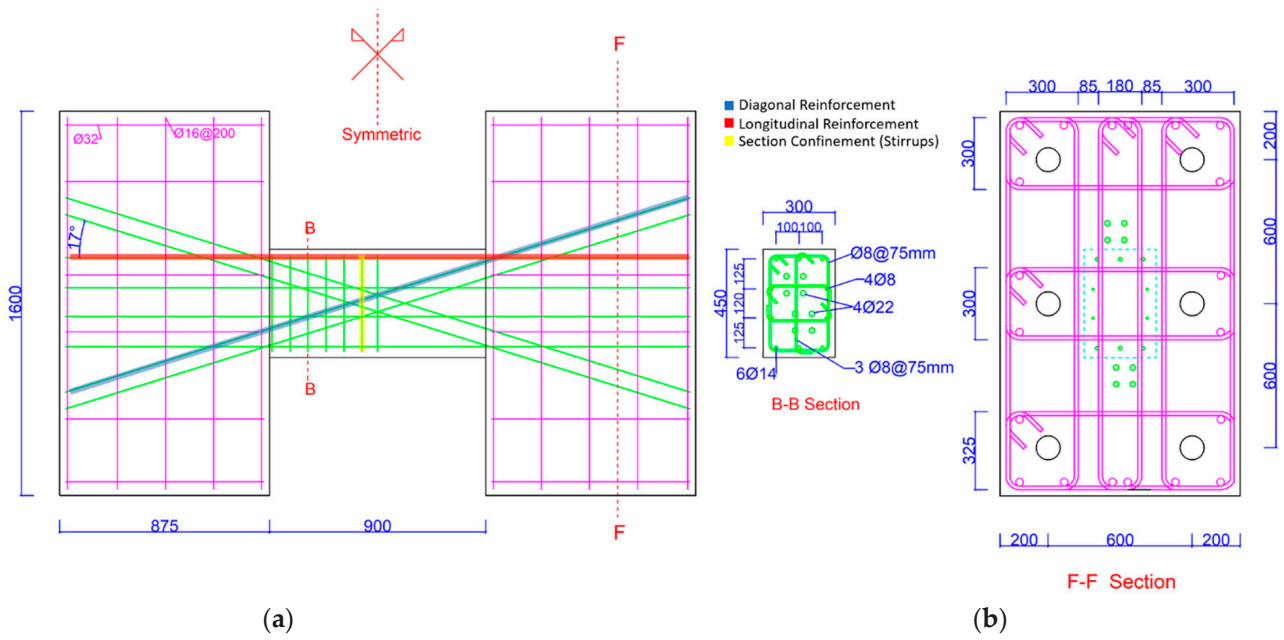
Figure 1. Detailing of CB2-UCB sample and geometry. (a) Geometry and details of samples; (b) Section details.

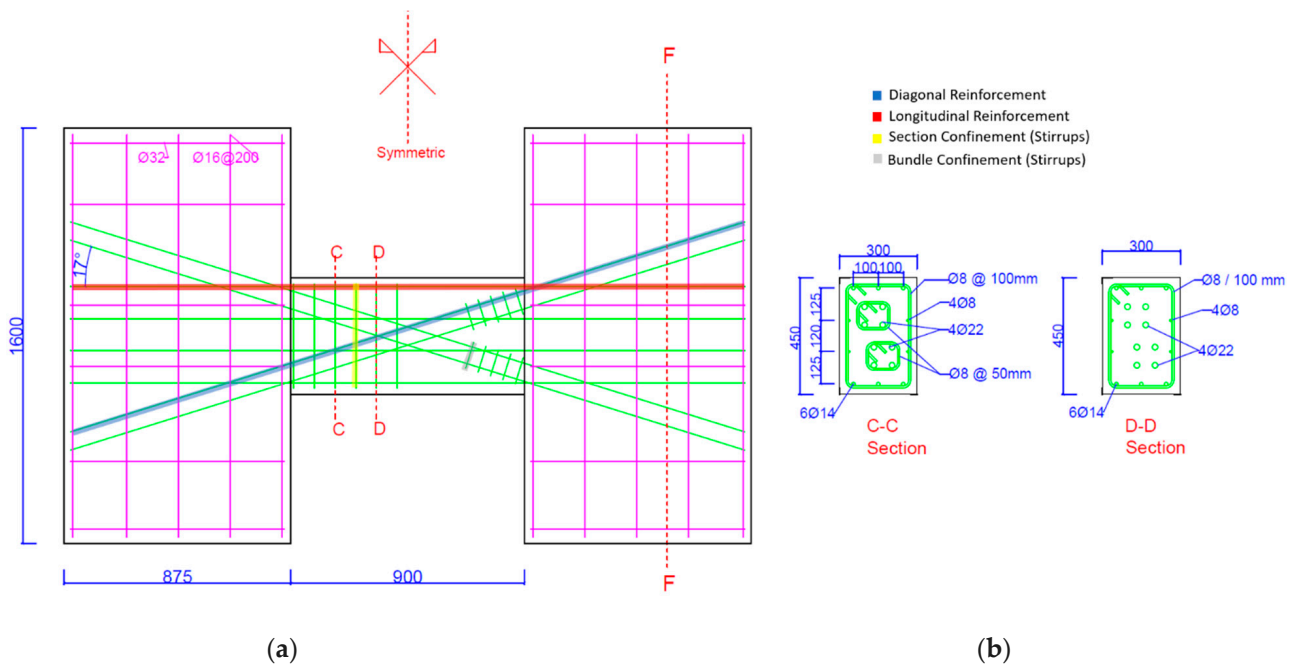
Figure 2. Detailing of CB2-PCB sample and geometry. (a) Geometry and details of samples; (b) Section details.

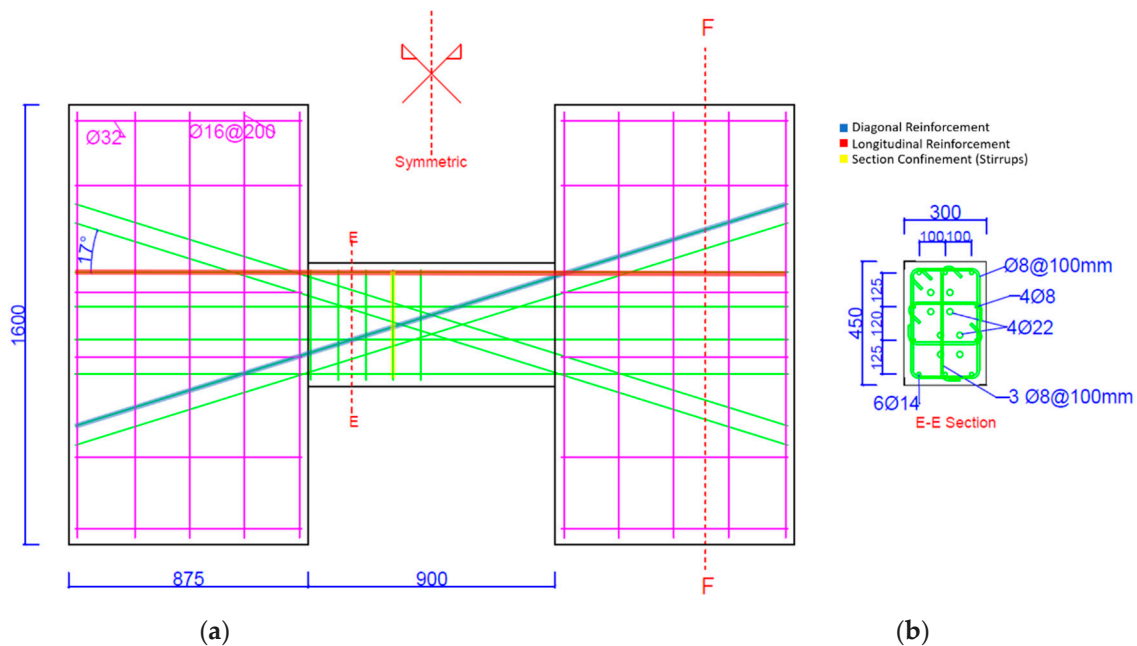
In CB2-RCR, the reduction in the confinement ratio implied that the diagonal beam was fully confined, but with a decreased stirrup ratio, while the diagonal bundles remained unconfined. This unique configuration allowed pushing the coupling beams to their lower boundaries, inflicting damage, and then assessing the effectiveness of the potential retrofitting strategies.

**Figure 3.** Detailing of CB2-RCR sample and geometry. (a) Geometry and details of samples; (b) Section details.

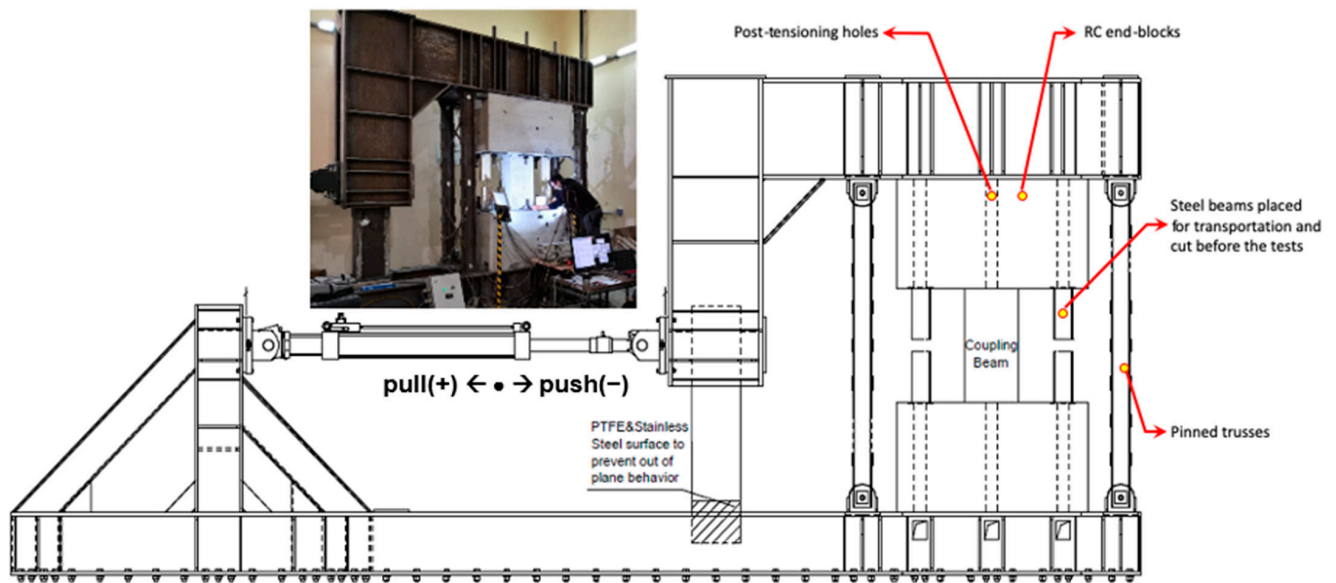
All samples were tested by the setup shown in Figure 4. As the test setup is a self-contained closed system, it does not need a rigid reaction wall. Post-tension is applied so that the upper and lower blocks have a rigid connection. Differential displacements between the steel frame and blocks were monitored throughout the test. Four vertical pin-connected steel columns are attached to both sides of the coupling beam. This is because the coupling beam prevents any rotation at the top block during testing. A rigid box fitted under the L-shaped loading frame is designed to prevent out-of-plane rotation and torsion behavior of the frame and to slide between the lower H profiles. Polytetrafluoroethylene (PTFE), a stainless steel surface, and grease lubrication were used to minimize friction and provide adequate pressure resistance. The lateral load was applied via three horizontal actuators. The lateral load, passing through the mid-span (mid-height) of the test specimen, provided zero moments at the mid-span of the beam.

Figure 4. Test setup.

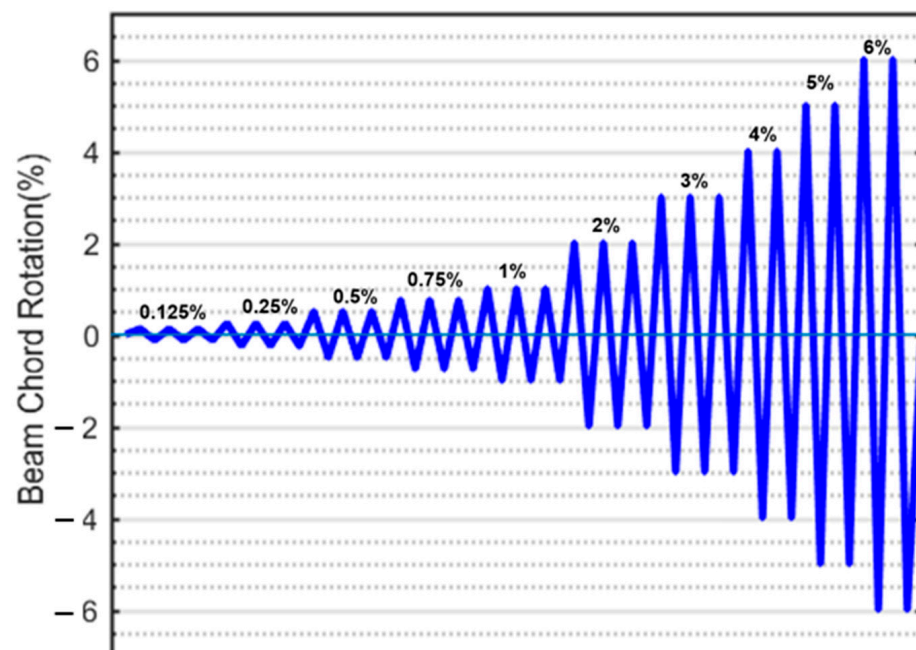
The testing procedure involved a combination of displacement-controlled cycles. Under displacement control, three cycles were carried out at every incremental increase in chord rotation, up to a limit of 3%. This limit corresponds to an approximate value for the allowable collapse prevention (CP) limit state specified by ASCE 41-06 [34]. For chord rotations exceeding 3%, two cycles were implemented for each subsequent incremental increase. The loading protocol is visually represented in Figure 5.

Figure 5. Loading protocol.

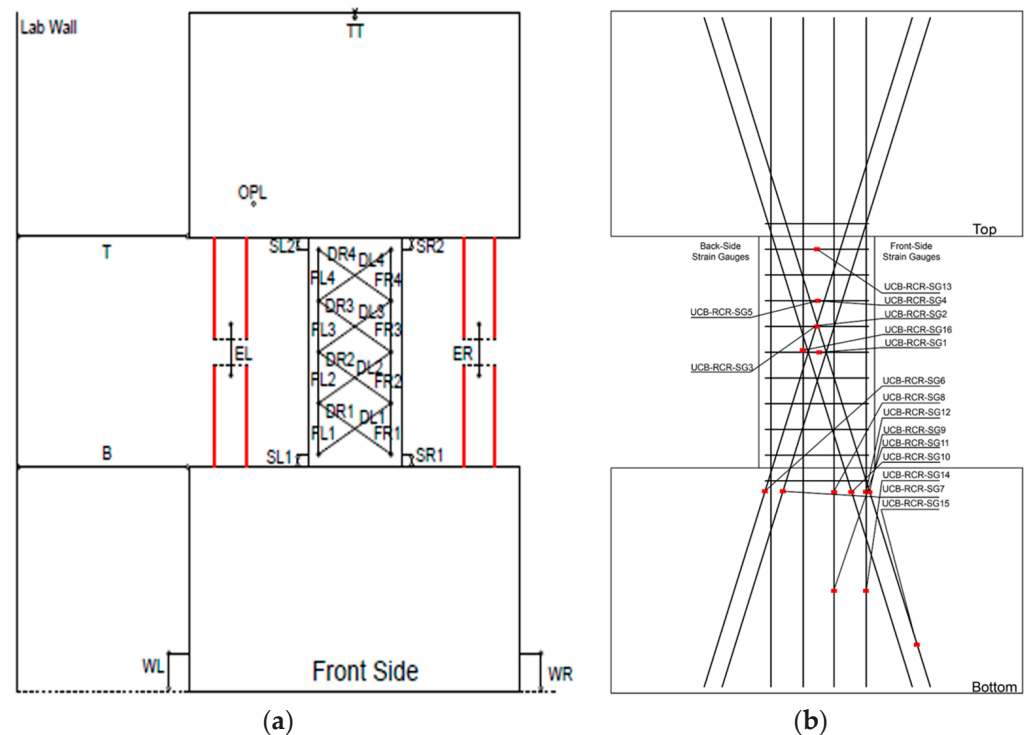
In addition to the strain gauges, potentiometers were employed to measure bending, shear, shear-elongation, shear, and axial deformations along the beam (as depicted in Figure 6). However, it should be noted that data could not be obtained from the specimens after the strengthening process for the 16 strain gauges placed following damage, which rendered them unusable for further testing. Nevertheless, potentiometers positioned on pendulums and on the sample were successfully employed to capture important data during the experiments.

**Figure 6.** Potentiometer layout (a), layout of strain gauges placed on the CB2RCR sample (b).

For researchers who want to access and analyze the experimental data, a quick summary of the explanation of the symbols in Figure 6, which describes the configuration of the potentiometer and strain gauges used in the experiment, is provided below [35].

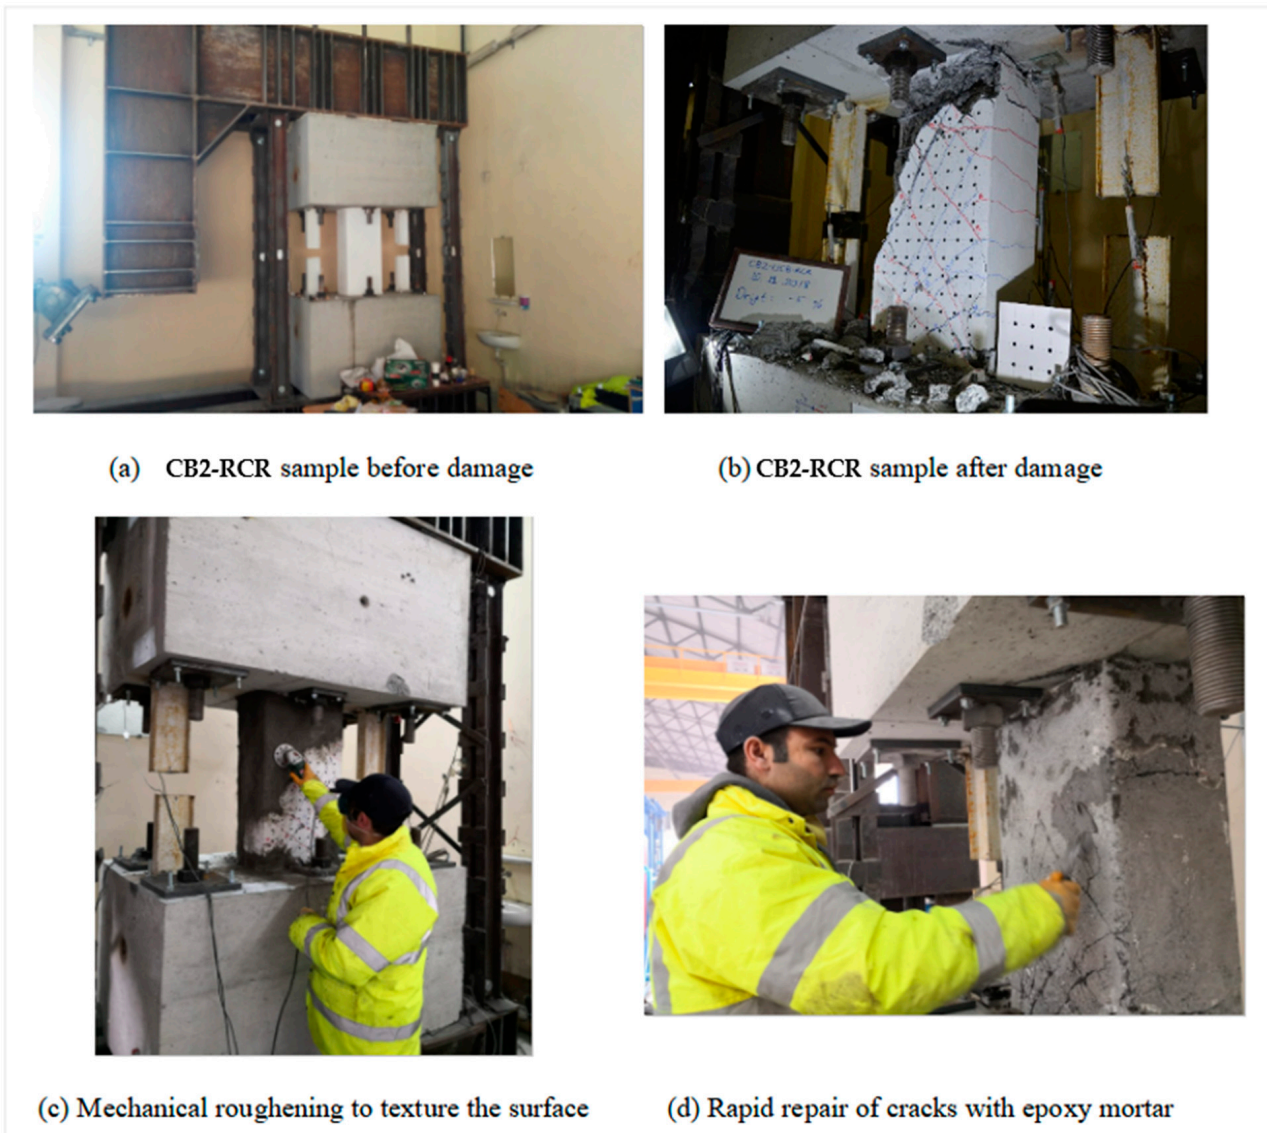
Figures 7 and 8 show the thorough execution of these preparatory stages, which seek to achieve a smooth integration between the restored substrate and subsequent strengthening materials. These graphic representations provide a full view of the step-by-step process of specimen repair and strengthening underpinning the applied experimental technique. Below, details of each stage of the strengthening application are given:

**Figure 7.** Stages of inflicting earthquake damage and strengthening on the CB-RCR specimen.

Before moving on to the evaluation of the test results, it would be appropriate to start a discourse on the concept of axial elongation. Axial deformation relates to the longitudinal elongation that occurs in coupling beams, which distinguishes them from conventional beams. The amount of elongation per unit length of the beam gives the axial deformation. This deformation, explained through analysis of crack patterns and principles of structural mechanics, is observed by the formation of dense diagonal shear cracks (see Figure 7).

Large, inclined shear cracks can be observed in the coupling beams, according to the crack pattern in Figure 7. They were created between inclined shear cracks and diagonal concrete struts. From the perspective of static balancing, the longitudinal component of the compression pressures pushes the wall panels, lengthening the coupling beams, while the transverse component resists the applied shear load. From a kinematic perspective, the diagonal concrete struts rotate around the compressive corners of the coupling beam

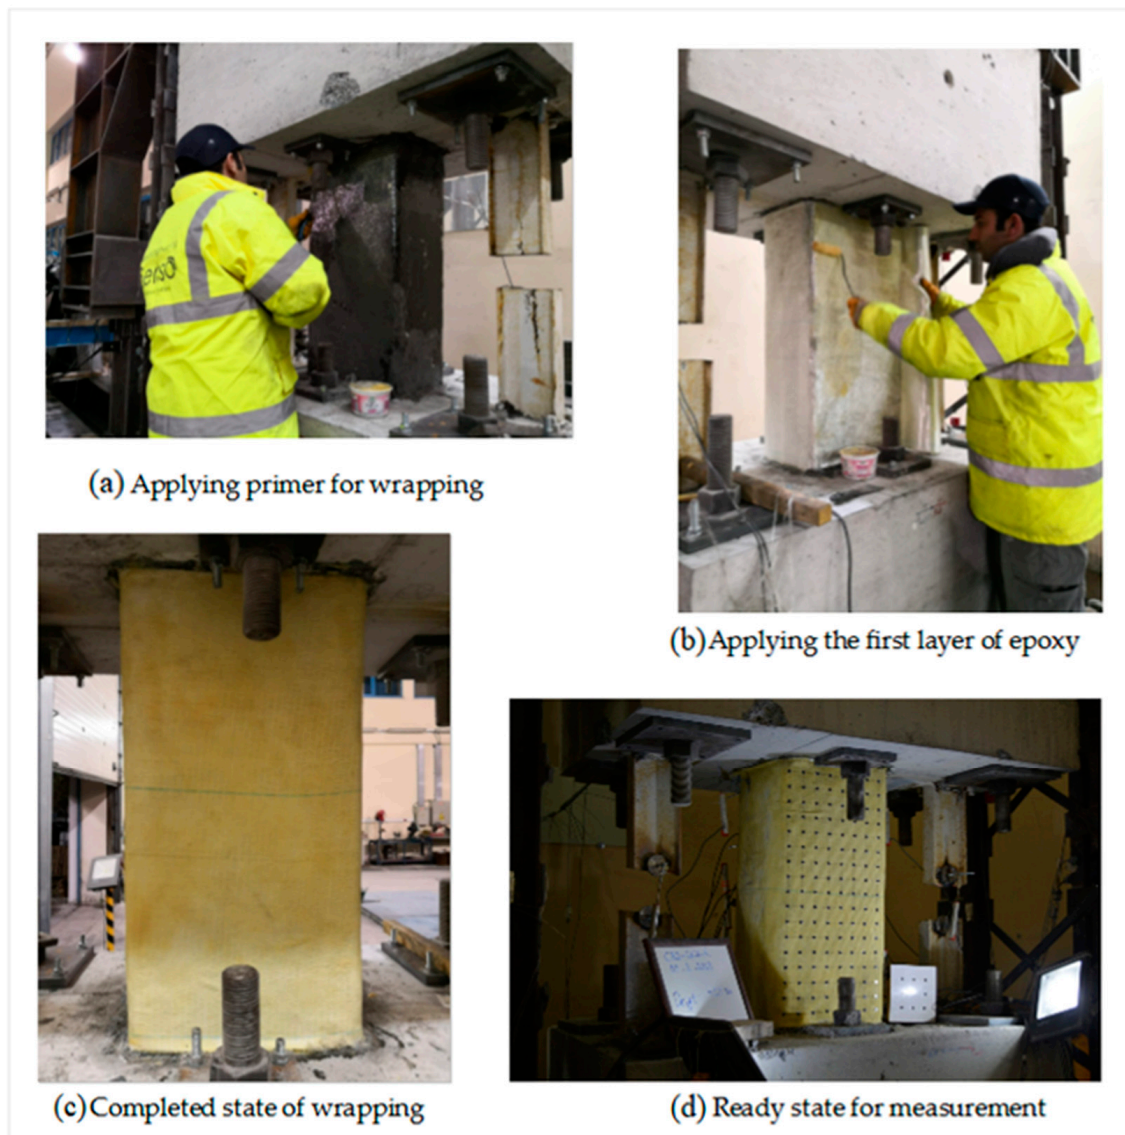
**Figure 8.** Stages of wrapping the CB2-RCR specimen with GFRP and preparing it for testing.

Following the manufacturer's guidelines, two-component epoxy resin was prepared. The epoxy resin was spread onto the designated area of the concrete surface where the GFRP would be placed. GFRP fabric was then positioned onto the wet resin, using brushes and rollers to ensure proper impregnation and the removal of air bubbles. Additional resin was applied to achieve complete saturation of the GFRP.

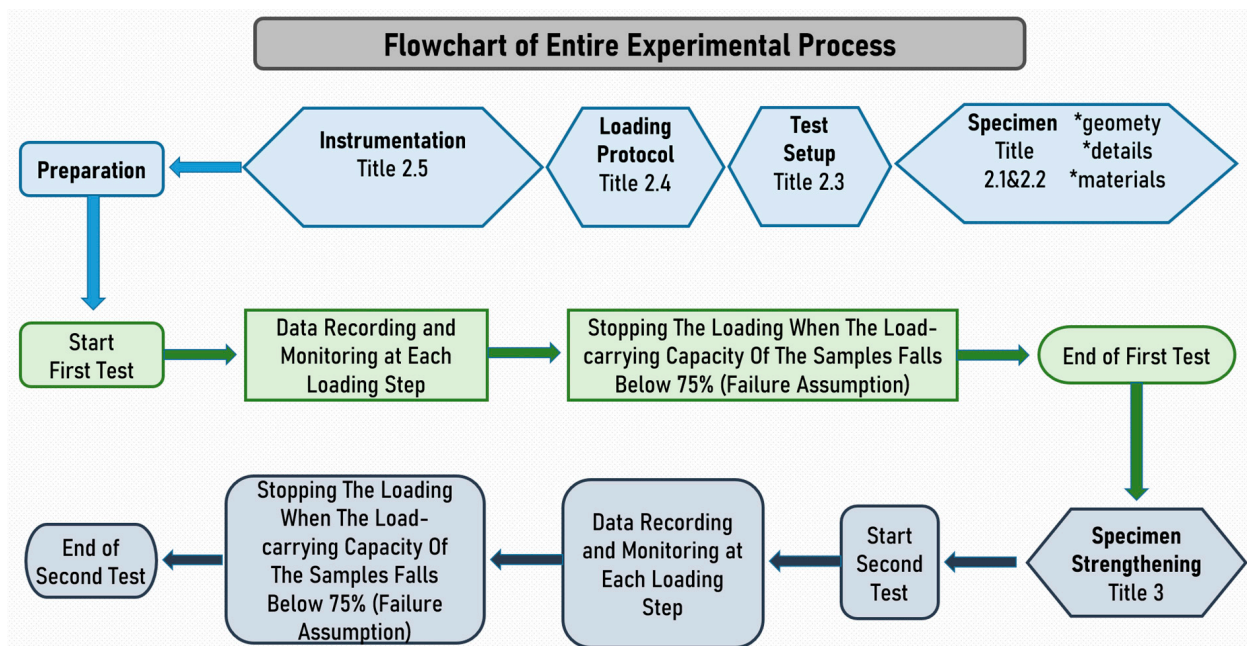
The schematic representation of the step-by-step progression of the conducted experimental studies is visually presented in Figure 9, mirroring the sequential phases as outlined. Commencing from the inception of initial specimens and extending through the preliminary seismic assessments, subsequent phases encompassing the reinforcement of damaged samples and their subsequent re-subjection to seismic testing are comprehensively depicted. This visual depiction serves as an illustrative guide, offering a concise overview of the entire experimental process, from the fabrication of the initial specimens to the ultimate phase of post-reinforcement seismic evaluations.

Figure 9. Flowchart illustrating sequential phases of experimental studies.

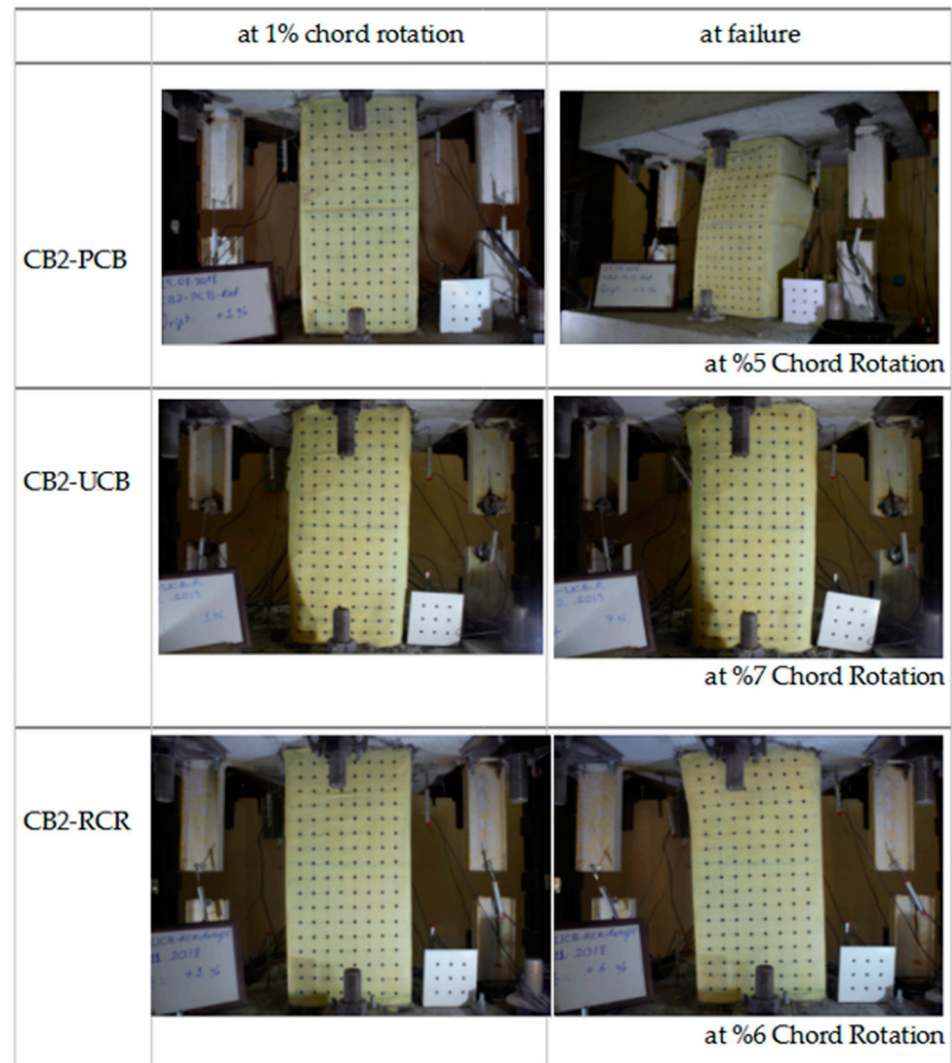
**Figure 10.** Conditions of the samples during the tests.

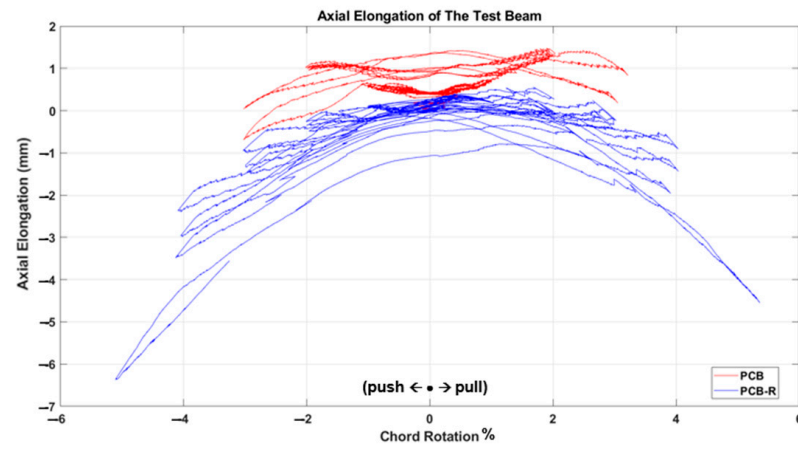
The test results, depicted in Figures 11–16, include the axial elongation and shear force distribution via chord rotation. Notably, the axial elongation values predominantly exhibited negative behavior. This can be attributed to several factors associated with the repair and retrofitting process of the damaged beam:

Figure 11. Comparison of the axial elongation of PCB specimen before and after strengthening.

In conclusion, the negative axial elongation (shortening) values observed in the tests can be attributed to the closure of cracks, plastic elongation, and buckling effects in the beams under cyclic loading. These findings provide valuable insights into the behavior of the repaired and retrofitted coupling beams, shedding light on their structural response and potential failure mechanisms. Understanding these factors is crucial for developing effective retrofitting strategies to enhance the seismic resilience of reinforced concrete structures.

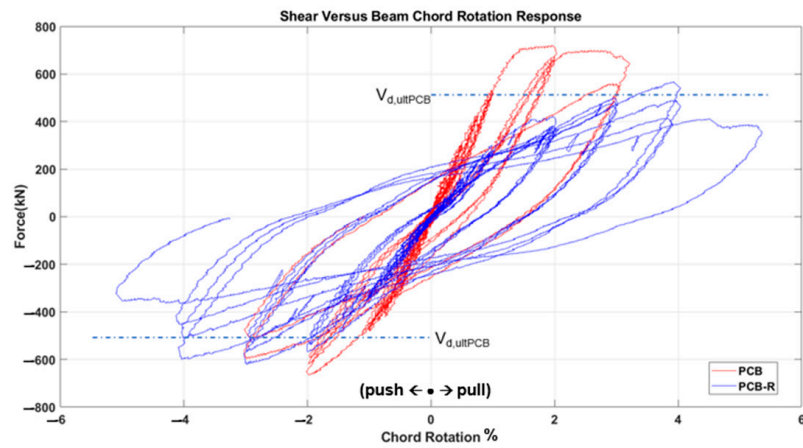
Figure 12. Comparison of pre- and post-strengthening shear force and chord rotation of PCB specimen.

- Partial Confined Bundle (PCB) Specimen:
  - The initial strength of the PCB specimen was higher than the strength after strengthening, but the rate of strength reduction decreased after damage (i.e., a more ductile behavior was obtained).

- The initial stiffness decreased by approximately 50% after damage at 1% chord rotation.
  - The degradation increased rapidly after reaching the displacement corresponding to ultimate strength as the confinement effect had already diminished in the first test state before strengthening. The strengthened specimen, on the other hand, still showed considerable ductility by exceeding the target displacements.

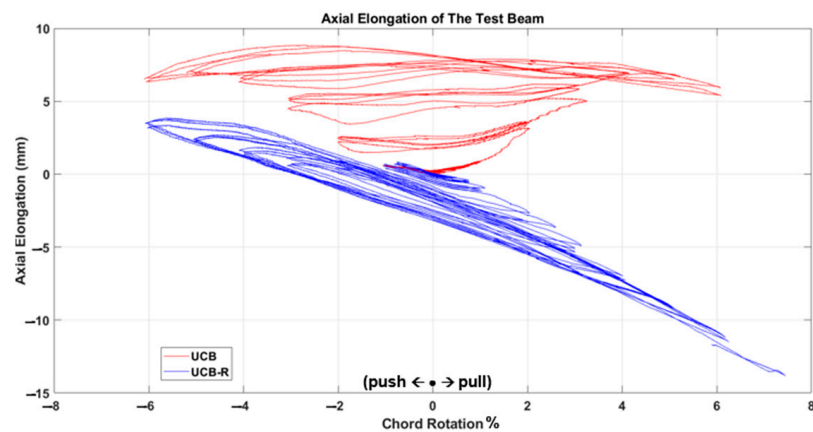
Figure 13. Comparison of the axial elongation of UCB specimen before and after strengthening.

Behavioral trends observed in the axial elongation graphs of two samples, UCB-R and UCB-RCR-R, which seem different at first glance, can be attributed to the fact that the damage occurred on different sides of the beam. All samples are tested under cyclic loading and the samples are symmetrical within themselves. However, the occurrence of damage on the positive or negative side with each charge cycle is a random event for symmetrical samples. According to the authors, the difference in tendency in the results does not indicate a behavioral difference.

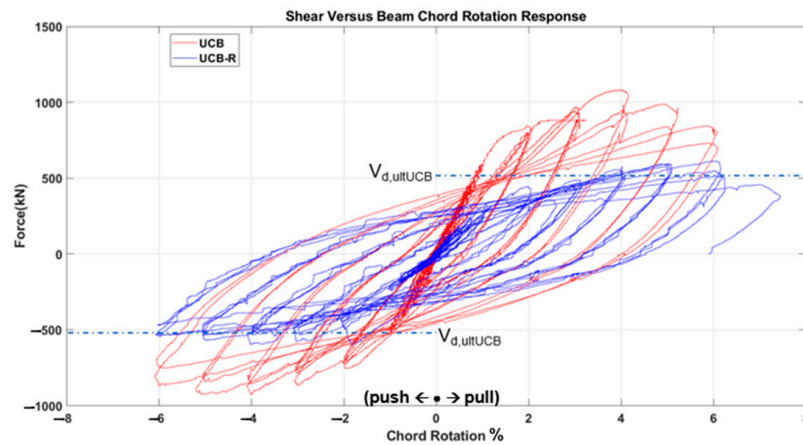
Figure 14. Comparison of pre- and post-strengthening shear force and chord rotation of UCB specimen.

- Unconfined Bundle (UCB) Specimen:
  - The strength of the UCB specimen was higher initially, before becoming damaged in the previous test campaign. After the strengthening, the strength reached approximately half the strength of the original (i.e., undamaged) specimen at similar chord rotation levels.

- The initial stiffness again decreased by roughly 50% at the 1% chord rotation value after damage.
  - The degradation tendencies were similar to the undamaged state in the strengthened specimen, but further accelerated with the diminishing wrapping effect at the end of the test.

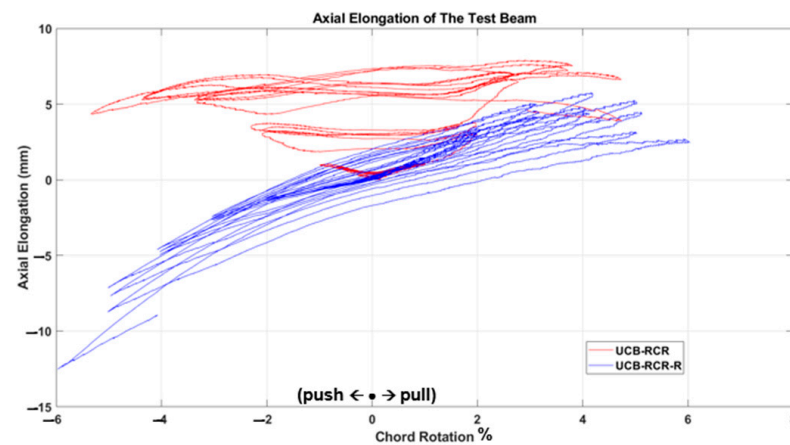
Figure 15. Comparison of the axial elongation of UCB-R-CR specimen before and after strengthening.

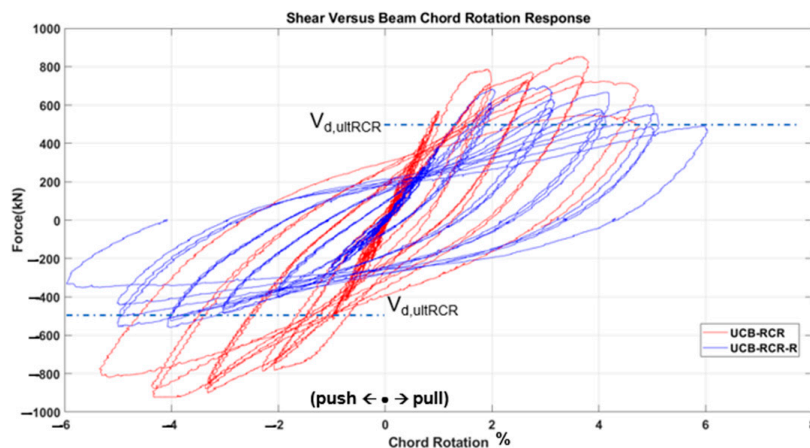
Figure 16. Comparison of pre- and post-strengthening shear force and chord rotation of UCB-R-CR specimen.

- UCB-Reduced Confinement Ratio (RCR) Specimen:
  - The strength was stable in the first cycles, but as the number of cycles increased, the strength of the strengthened specimen decreased further due to damage internally occurring behind the wrapping layer. This was observed during the test by the authors.

- There was roughly a 40% difference between the initial stiffness value at the 1% chord rotation value.
  - The strength degradation was higher in the initial test specimen with increasing chord rotations, while in the strengthened specimen, a higher chord rotation level could be achieved.

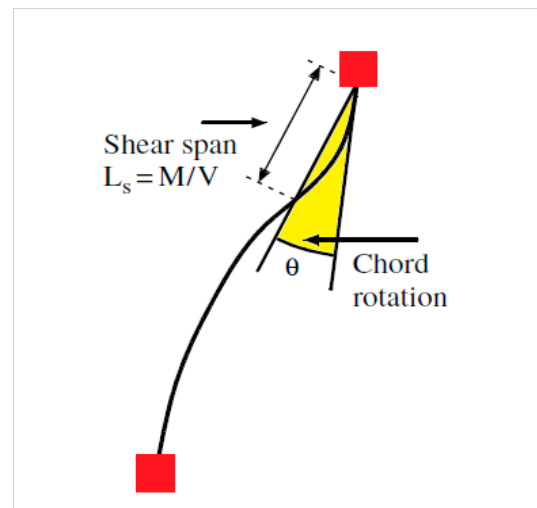
The graph below depicts the definition of the shear capacity and coupling beam chord rotation (Figure 17). The preservation of shear capacity in increasing chord rotations without a significant decrease in maximum shear capacity is a sign of a successful post-earthquake strengthening, meaning that the wall-to-wall interaction via the coupling beams can still hold for further displacements demands in the aftershocks. For instance, the diagonal rebars, which are responsible for directly resisting the shear forces acting on the beam, but are also susceptible to buckling, are successfully held by the confinement provided by the GFRP wrapping, hence retaining the shear capacity.

**Figure 17.** Chord rotation and shear span relation of the beam element.

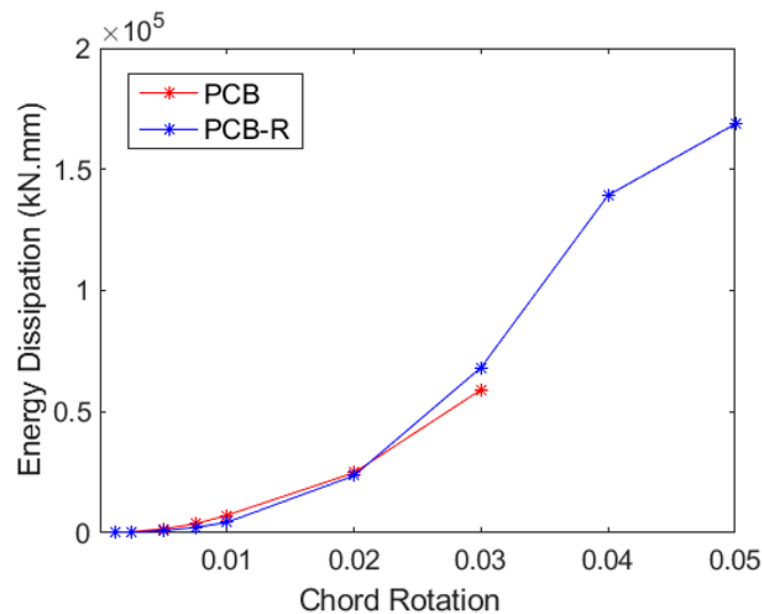
**Figure 18.** Cumulative energy dissipation for PCB and PCB-R specimens.

When the CB2-PCB (Coupling Beam—Partially Confined Bundle) sample is examined, it is seen that the chord rotation rate, which can reach up to 3% without GFRP wrapping, increases to approximately 5% after earthquake damage, after wrapping with GFRP. The specimen encased in GFRP also takes in around 5% more energy during the 3% chord rotation cycle. In this situation, it appears that the GFRP wrapping considerably increases the lack of confinement effect brought on by the coupling beam's absence of stirrups.

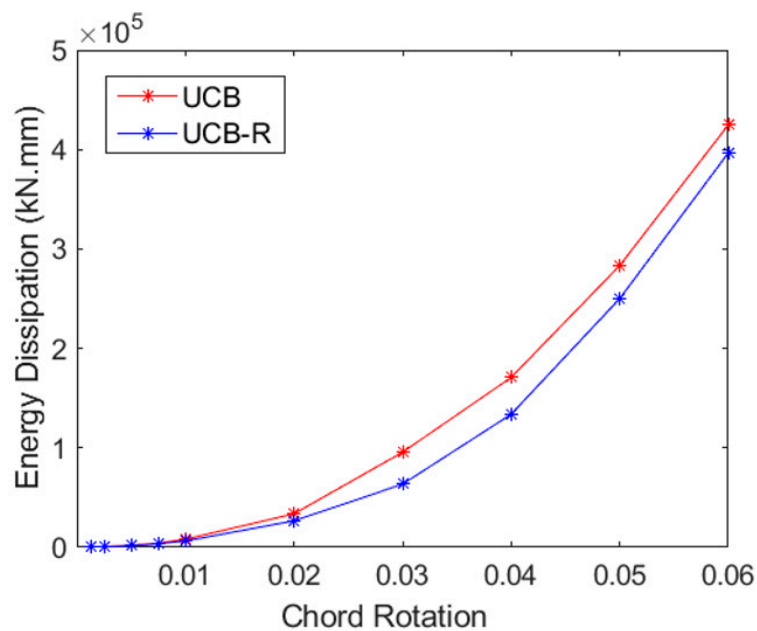
**Figure 19.** Cumulative energy dissipation for UCB and UCB-R specimens.

When the CB2-UCB (Coupling Beam—Unconfined Bundle) sample is examined, it is seen that the chord rotation ratio, which can reach up to 6% without GFRP wrapping, reaches the same level after earthquake damage and after GFRP wrapping. However, the specimen wrapped with GFRP absorbs approximately 15% less energy during the 6% chord rotation cycle. In this context, although the almost same confinement effect was achieved

with GFRP due to cracks and reinforcement damage in the web, which occurred despite the tight stirrup wrapping in the beam in the first case, the energy absorption capacity could only approach its undamaged state, not higher.

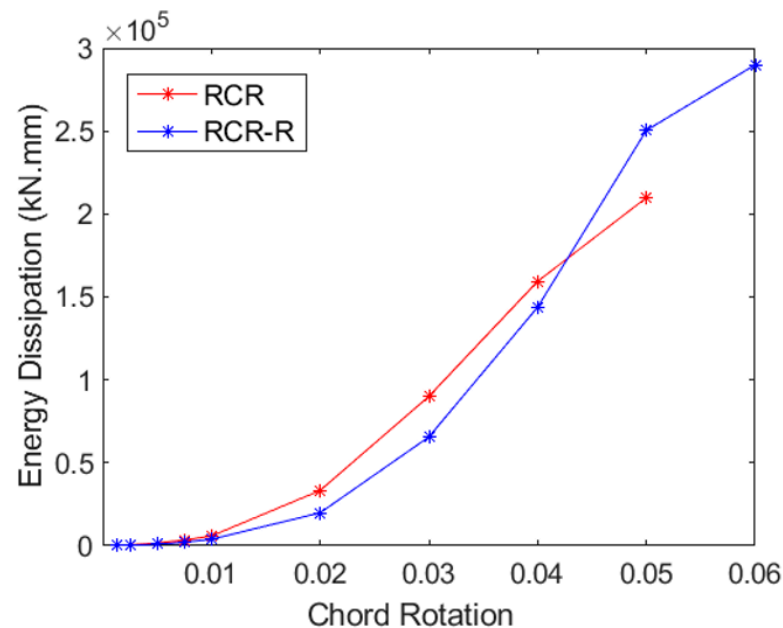
**Figure 20.** Cumulative energy dissipation for RCR and RCR-R specimens.

Evaluating the CB2-RCR (Coupling Beam—Reduced Section Confinement Ratio) sample, it can be observed that the deflection rate, which can reach up to 5% without GFRP wrapping, increases to about 6% following post-earthquake damage GFRP wrapping. Also, the specimen wrapped with GFRP absorbs approximately 25% more energy at 5% chord rotation cycles and beyond. This increase significantly resulted in 5% chord rotation instead of 6% due to the reduced confinement effect in the initial state of the beam compared to the UCB sample. However, the strengthening sample reached up to 6% chord rotation when the confinement effect was largely recovered with GFRP. As a result, it has increased its capacity to absorb energy. The contribution of stirrups on ductility and energy dissipation is evident in diagonally reinforced coupling beams based on these results, and it is rather difficult, if possible at all, to exceed their contribution by simply applying GFRP wrapping.

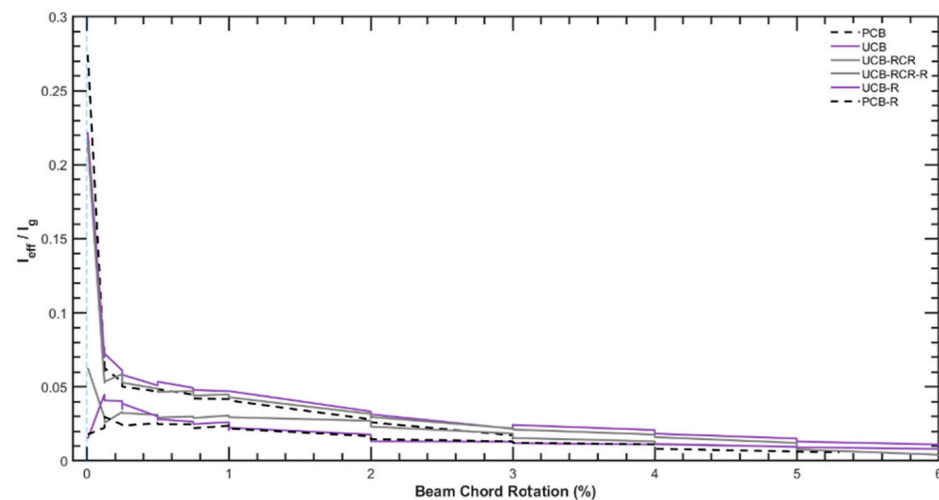
When analyzing the effective stiffness values, Figure 21 indicates that the values at the end of the tests before strengthening are predominantly maintained during the tests conducted after the strengthening process. This observation suggests that the strengthening measures applied to the specimens have effectively preserved their overall stiffness characteristics, especially after 2% chord rotation. This finding suggests that the retrofitting measures, such as GFRP wrapping and repair mortar application, effectively maintain the overall stiffness of the coupling beams even after undergoing cyclic loading and experiencing damage. The strengthening technique has successfully enhanced the structural stiffness, contributing to the improved performance and seismic resistance of the coupling beams throughout the test cycles. This finding further supports the feasibility and efficacy of the proposed strengthening approach in maintaining the structural integrity and enhancing the safety of the coupled wall systems.

**Figure 21.** Comparison of  $I_{eff}/I_g$  changes of samples before and after reinforcement.
