World Multidisciplinary Earth Sciences Symposium, WMESS 2015

Probabilistic Back Analysis of Landslides in Arakli-Tasonu Quarry, Northeast Turkey

Nurcihan Ceryan^{a*}, Ayhan Kesimal^b

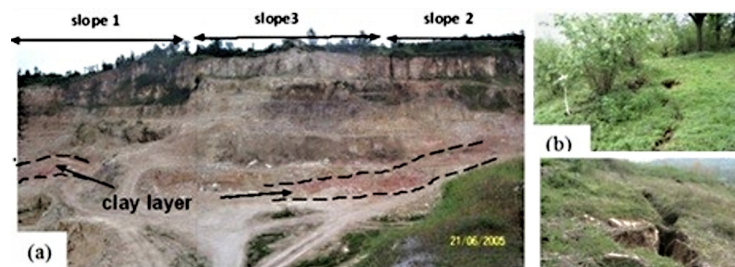
The bench faces of slopes failure have clayey levels, which are inclined in the same direction as the quarry slopes (Figure 2a). In April 2005, these layers of weakness appeared on the slope excavation, and tensile cracks 38–91 meters away from the excavation faces developed on the northern side of the quarry (Figure 2b). After this date, following the results of Kesimal et al. (2008), the production at the quarry continued using blasting. However, excavation by blasting had the least impact in terms of slope stability. After the cracks were noticed, they were marked on the topographic map and groundwater level in the cracks and drillings was measured after heavy rains. The mentioned landslides occurred over the failure plane in the clay layer.

Figure 2 (a) Excavation slopes where landslides occurred and previously developed tension cracks (b).

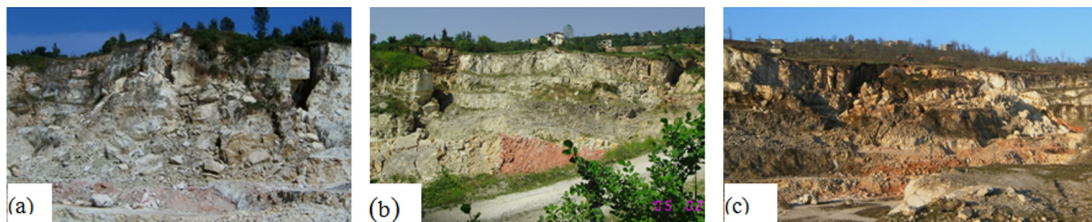
On 3 October 2005, a large rock—about 52 m high, 57 m wide, and with a length along the strike of 50 m—slid a distance of approximately 25 m along the red-white colour clayey layer dipping 14° into the quarry, following exposure of the sliding plane by blasting at the foot of the slope (Landslide 1, Figure 3a). Then, on 20 March 2006, a large rock—about 46 m high, 90 m wide, and with a length along the strike of 158.2 m—slid a distance of approximately 25 m along the clay layer dipping 14° into the quarry, following exposure of the sliding plane by bench blasting at the foot of the slope (Landslide 2, Figure 3c). Finally, on 19 October 2006, a large rock—about 48 m high, 77 m wide, and with a length along the strike of 138.3 m slid a distance of approximately 25 m along the clay layer dipping 14° into the quarry, following exposure of the sliding plane by blasting at the foot of the slope (Landslide 3, Figure 2b). These failures were developed on the same the clay layer (Figure 3a-c and Figure 4). The inclination of the clay layer, which is the failure plane, was measured at 14° . This red-white colour layer was formed by weathering of tuffit. The thickness of the clay level ranges from 30 to 115 cm. The surfaces of the limestone layers above and below the sliding surface were planar with a slight roughness. Since the thickness of the clay layer was greater than the amplitude of roughness of the bedding plane, the sliding plane passed through the layer of clay. Index properties, mineralogical characteristics, shear-strength properties of the clay layer and the failure plane of the landslides were determined in the laboratory using samples taken from the clay layer in the landslide area.

Figure 3. The landslides occurred on 3 October 2005 (a), 20 March 2006 (c) and 19 October 2006 (b) in Araklı- Tasonu Limestone Quarry.
