Effect of patch geometry and resin type on mechanical properties of repairing deep scratch damage to aircraft composites

Keywords: composite aircraft structure, repair process, thermoset resin, continuous glass-rovings, deep scratch damage

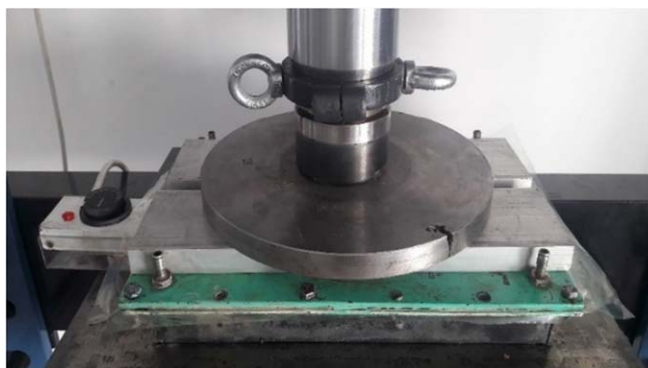
Figure 2. Composite plate manufacturing by hot-pressing.

In the second phase, six composite plates ($V_f \approx 55\%$) were produced from 300 g m^{-2} glass-woven fabric with 12 layers, dimensions of $270 \times 360 \text{ mm}$, and thickness of 2–3 mm using the hand lay-up and hot-pressing method. These plates are similar to the composite exterior components of aircrafts, such as fuselages, wings, tail stabilizers, and doors. For this purpose, the glass fabrics were first impregnated with Duratek® epoxy in accordance with the hand lay-up method, and then laid on top of each other in the metal lower mold cavity. The upper mold was then closed, and as shown in figure 2, the laminates in the metal mold were cured in a 60-ton press at $100 \text{ }^\circ\text{C}$ and 30 bar pressure for 4 h. The heater was then switched off and the plates were left to cool under constant pressure for 24 h.

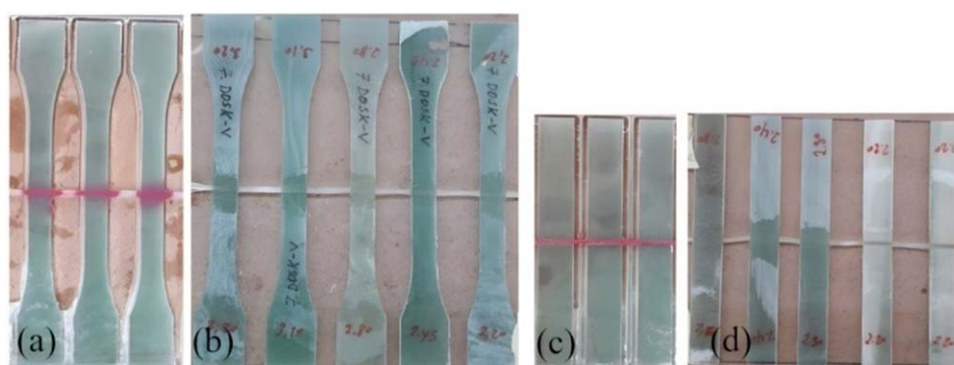
Figure 5. Tensile and flexural specimens cured at 23 °C/24 h.

(6–9 times) until the deep scratches were covered ($V_f \approx 40\%$). Subsequently, the composite samples with the repair filling were cured under various conditions. These conditions included a room temperature of 23 °C for 24 h (figure 5), 40 °C with a 250 W infrared lamp for 4 h, and 60 °C for 2 h (figure 6).
